## **Summary of events**

### **Grampian Commander / Nelson Location**

### **Marine Safety Forum**

**28<sup>th</sup> May 2009**

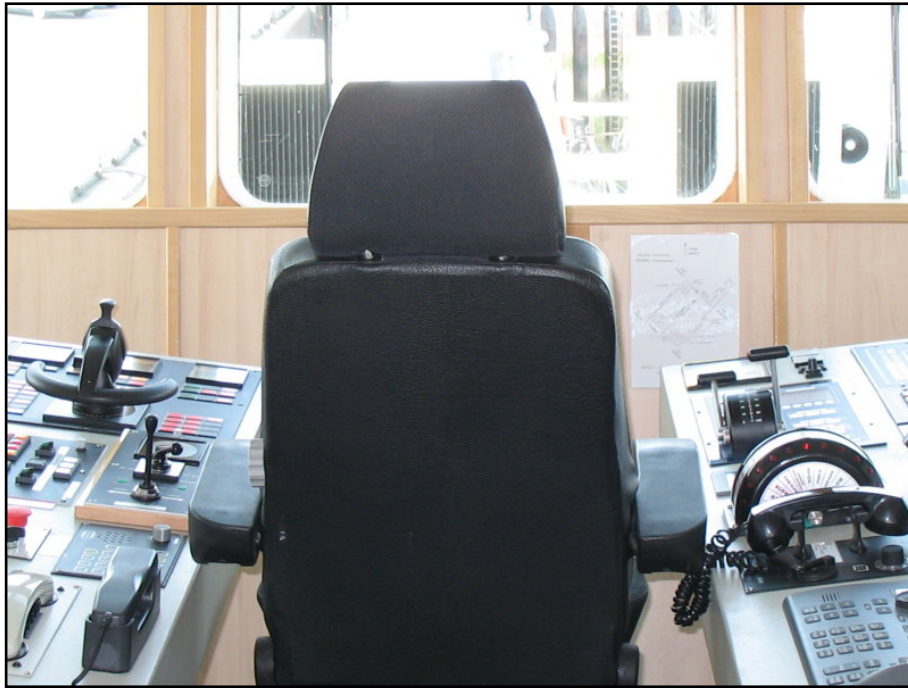
Fore bridge looking forward

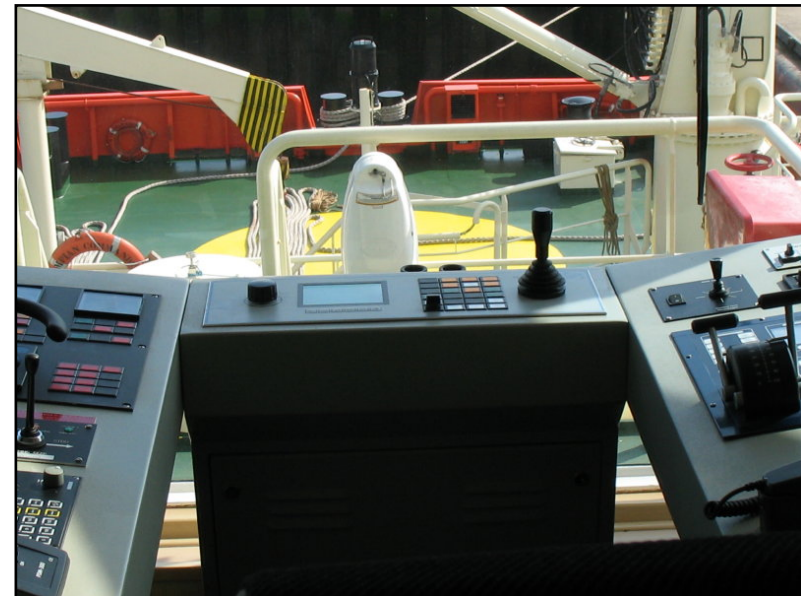
Aft bridge looking aft

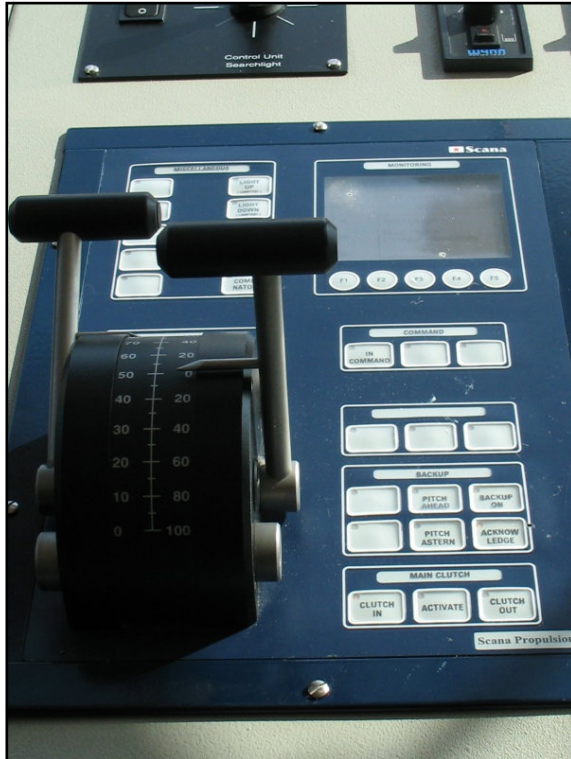
ME CPP control at  
Aft Bridge

- The balance of probability would indicate that the Master of the Grampian Commander accidentally applied stern pitch to the main engine propeller whilst trying to accept a spurious alarm by means of various button presses on the forward command consol, in particular the buttons on the back up pitch controller.

- The Master activated the buttons without the aid of his spectacles, and the buttons were activated by leaning over the console and looking at them from the wrong angle. (effectively upside down).

<b>ACTIONS TAKEN</b>	<b>Status</b>
Fleet alert transmitted	
Fleet circular transmitted regarding watch-keeping	
Exponential thrust increase modified	
Investigation of spurious alarm to be completed and repair effected	
Pitch controller system checked and verified	
<b>ACTIONS OUTSTANDING</b>	<b>Status</b>
The Master to be reprimanded over stationing his vessel too close to the location and in breach of close standby procedures.	
The Master to be retrained in close standby procedures, and in the accurate judgement of distances utilising various methods. (Visual, optical and electronic).	
Optical method of accurate range finding to be sourced, tested and distributed to the <b>fleet</b> .	
During close standby ops, the Deckhand watch keepers role to be clearly defined in respect to watch keeping duties and assisting the officer of the watch.	
Share findings with MSF and through-out the fleet.	
The Layout of the CPP controls to be reviewed with manufacturers to eliminate the possibility of re-occurrence.

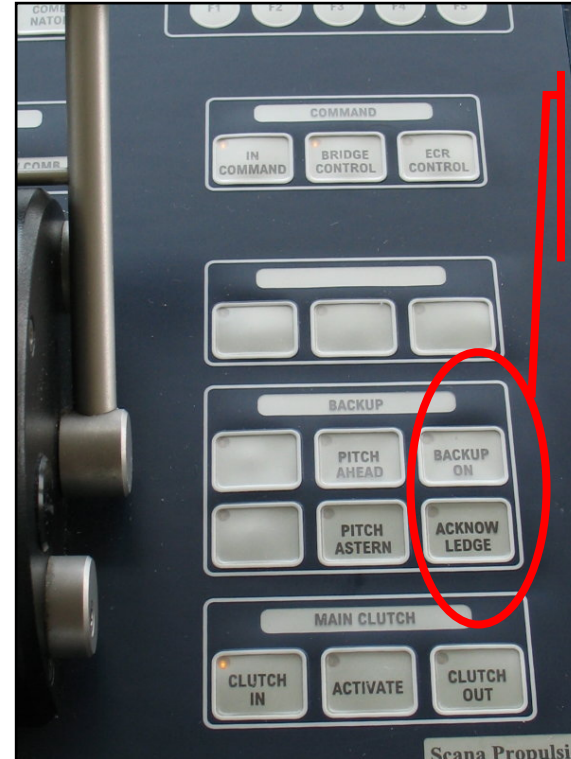
ME CPP control at  
Fore Bridge

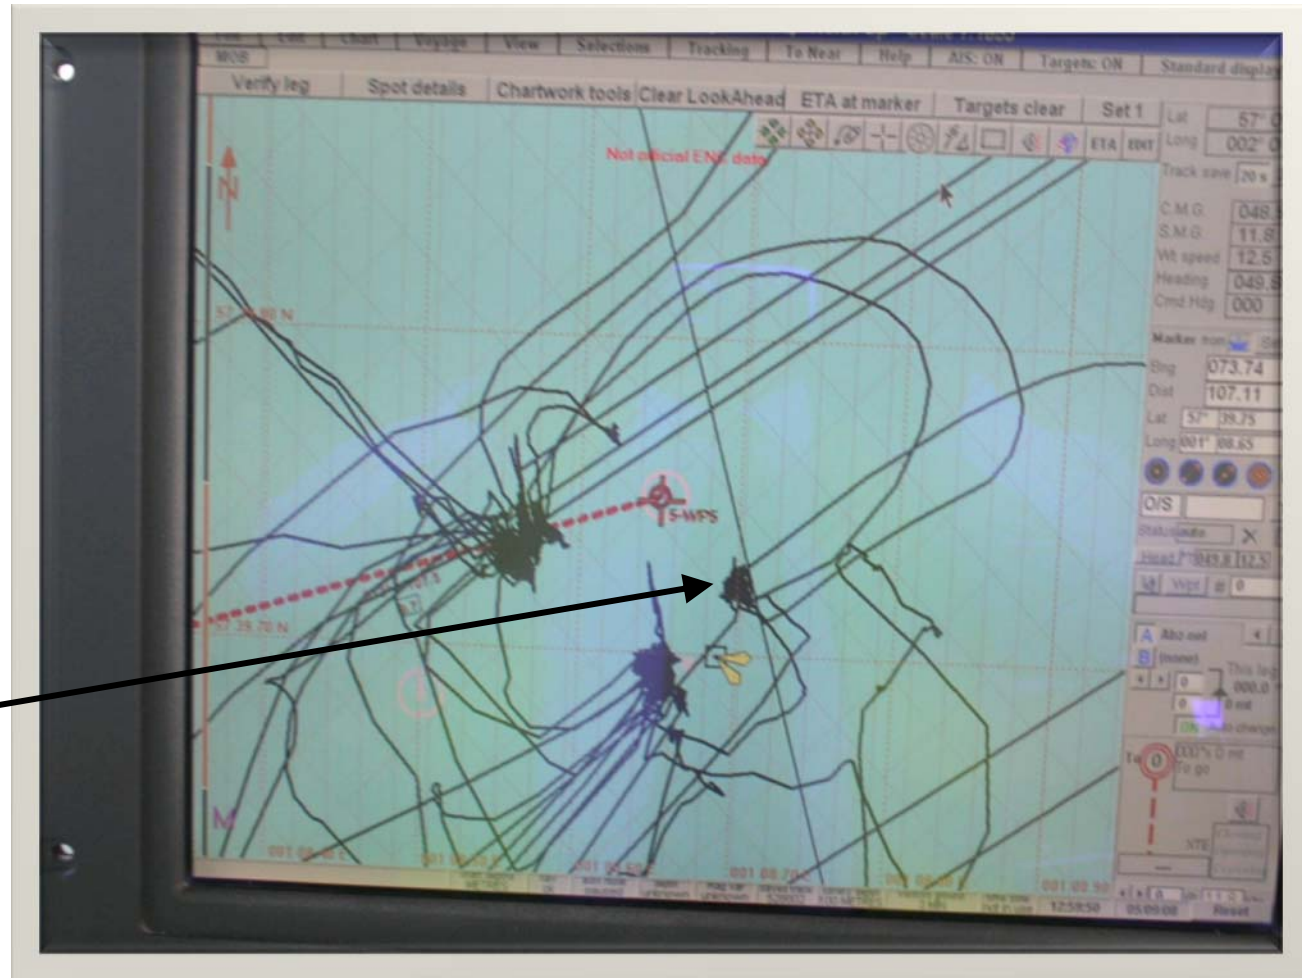
## Microplot history print

Note proximity  
To platform

- The above action was compounded with the fact that the vessel was operating less than 100 yards from the location, significantly less than our procedures allow.

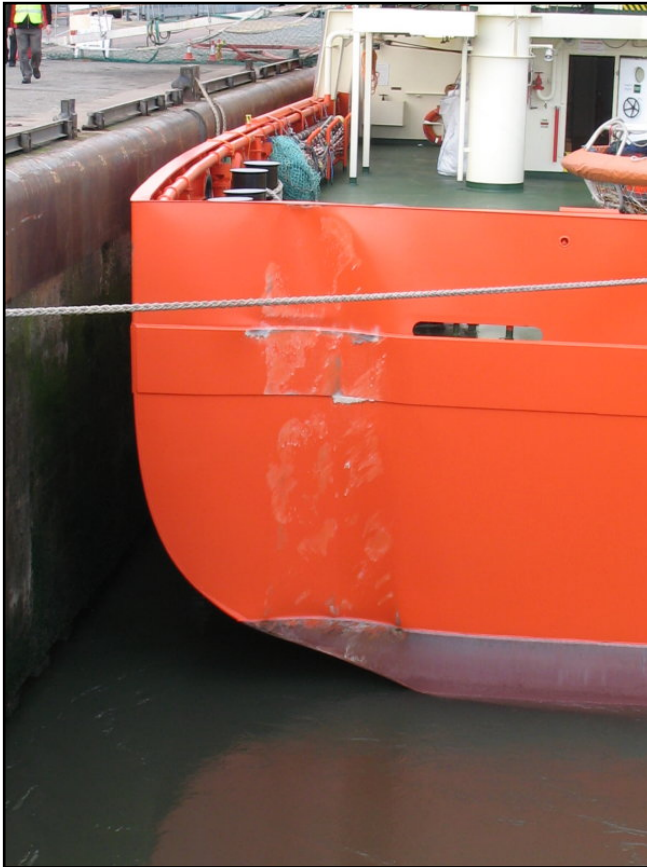
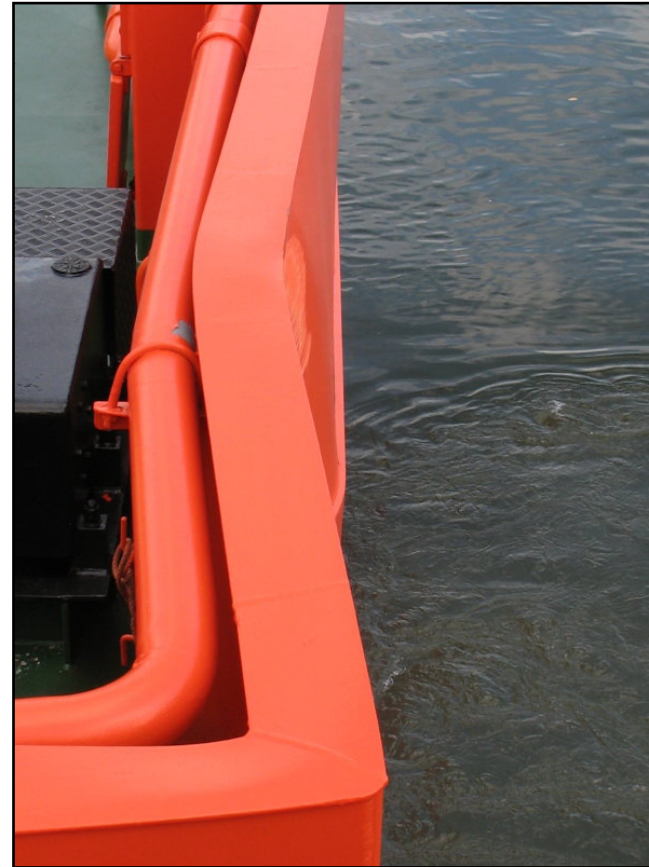
Stern views of Grampian Commander
