Platform Collision Incident

Aberdeen Airport Thistle Hotel

Collision with Leman AK/Seafox 4

1st October 2007

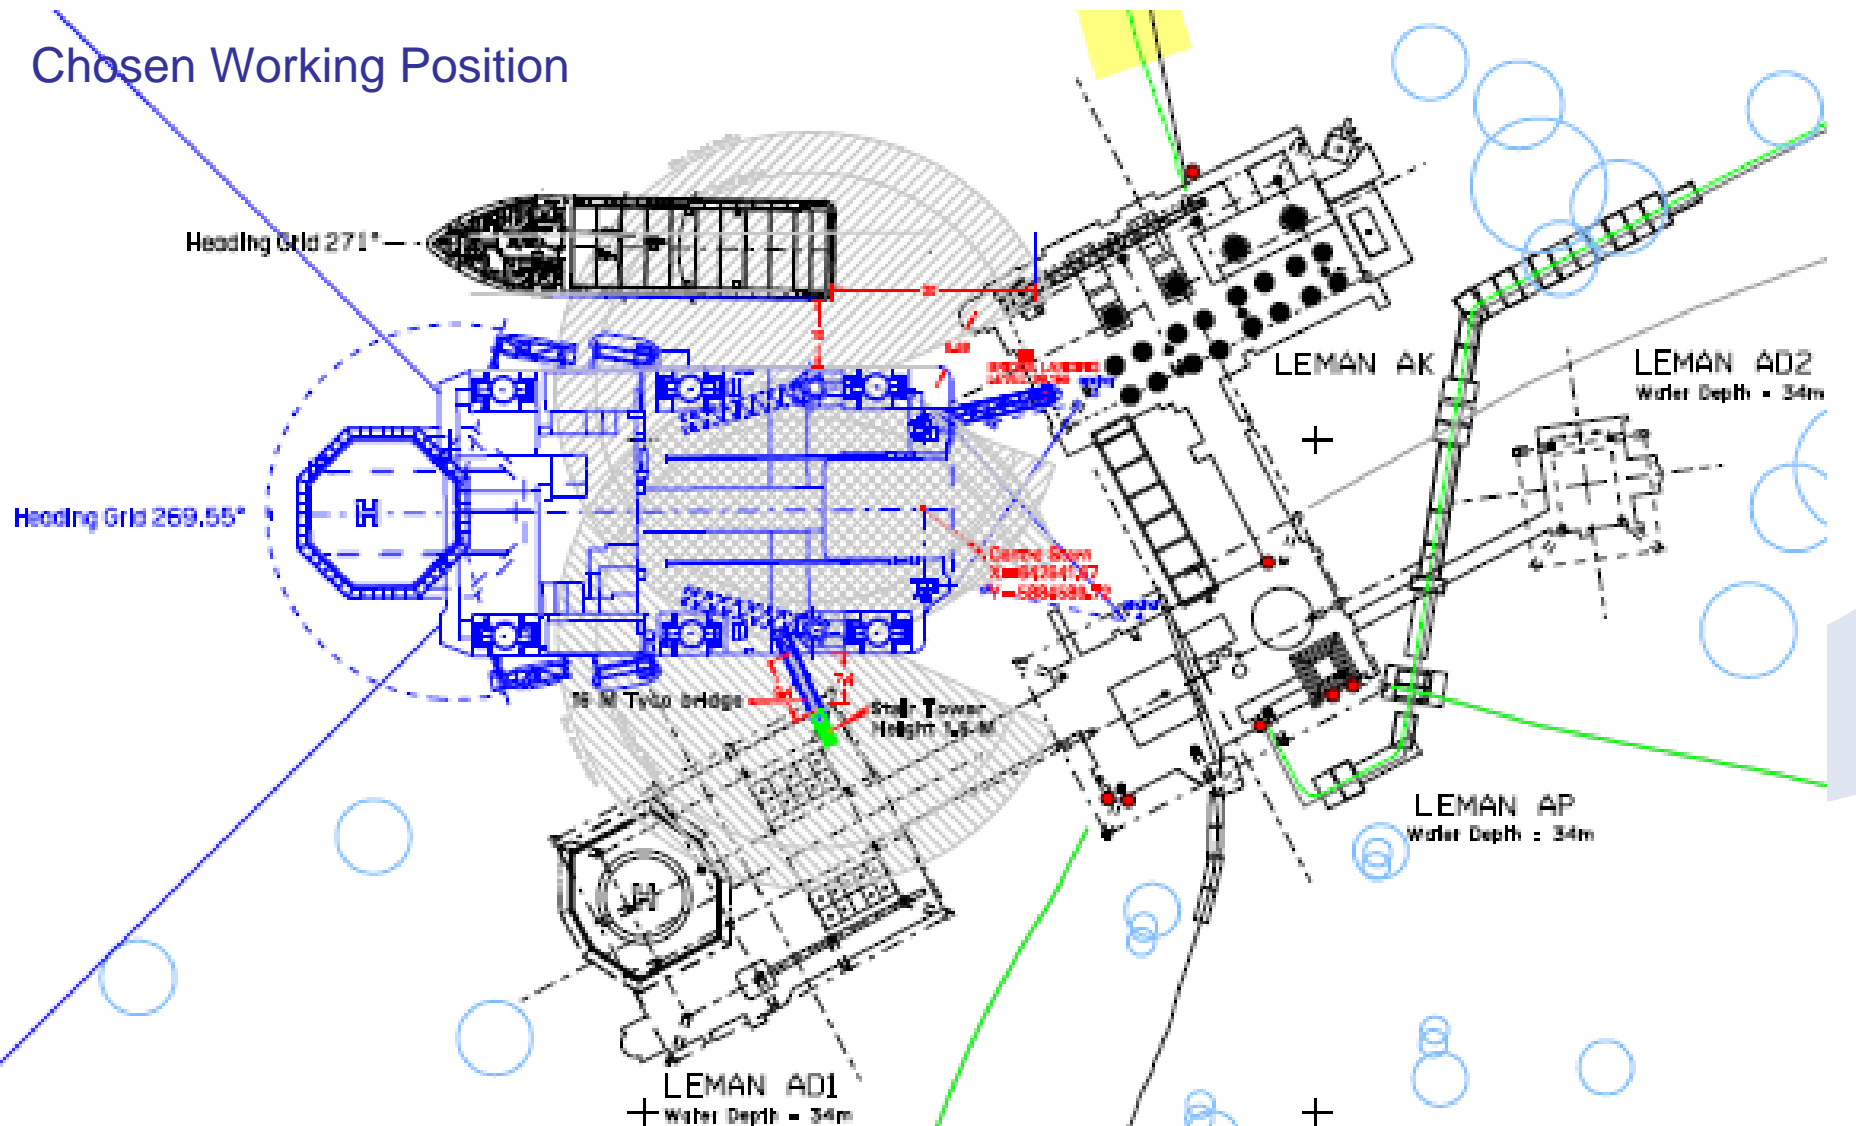
Chosen Working Position

- *Choice of low speed for thruster motors prior to manoeuvres left insufficient reserve power when tidal conditions changed.*
- *Choice of heading required more power to maintain position than stemming tide.*
- *Bridge team had not fully appreciated the effects of the tide*

- *Safety alert issued to fleet and one to issued through MSF reminding all of the requirements not to exceed 50% power to maintain station (NW European Guidelines).*
- *Develop ship-specific 'bridge operations manuals' for each ship.*
- *Increase use of ship simulators for familiarisation training.*
- *Provide enhanced tidal prediction facilities to vessel*
- *Amend 500m zone checklist to include validating tidal information.*

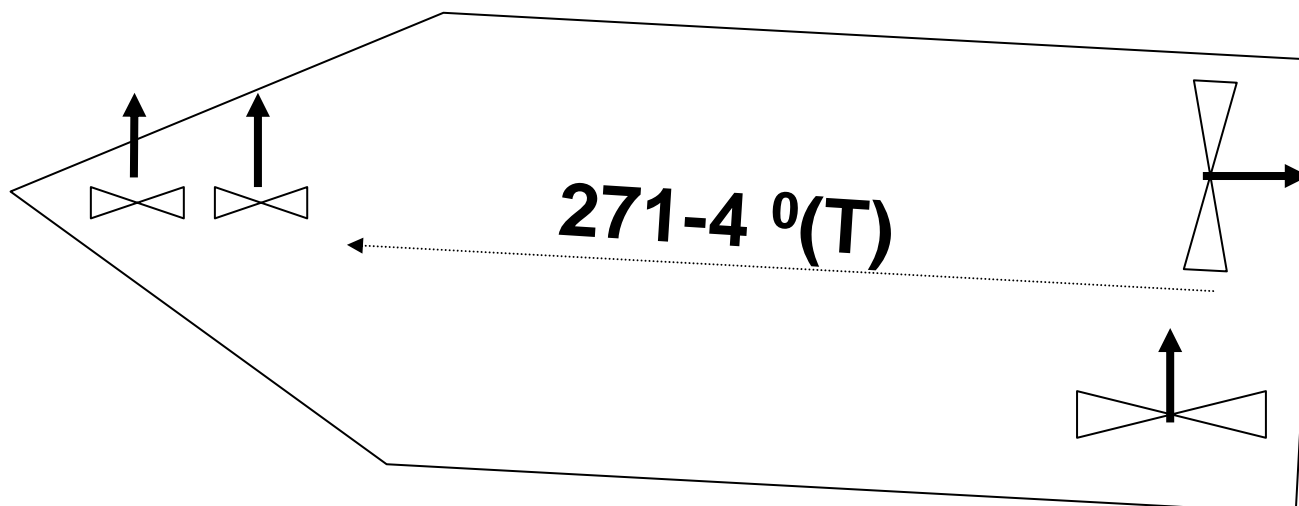
Liaaen Azimuth Thrusters

Two power settings available
High RPM = 1,166 kW (1,500 HP)
Low RPM = 522 kW (700 HP)

Brunvoll Tunnel Thrusters

Two power settings available
High RPM = 515 kW (700 HP)
Low RPM = 330 kW (450 HP)

Potential Losses

Azimuth Low Power 55%
Astern pitch 20% approx
Joystick 20% approx
