*Far Grimshader - Songa Dee collision: 18<sup>th</sup> Jan 2010.*  
*Incident findings and lessons learnt*

MSF AMM: 27<sup>th</sup> May 2010

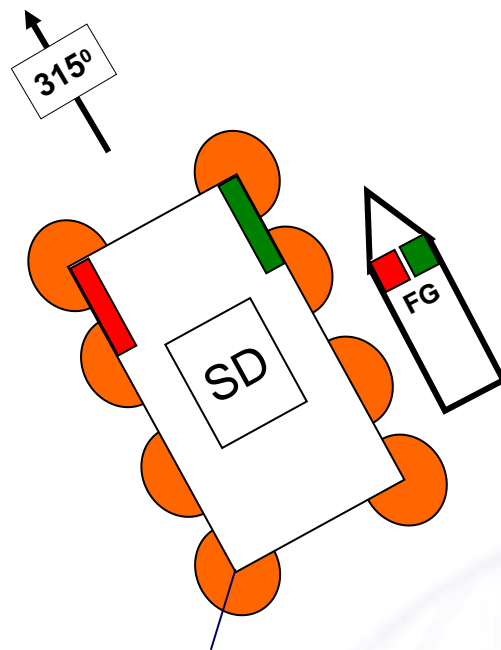
**Time:**  
21:20

**Manoeuvre:**  
Holding position

**Event:**  
Songa Dee starboard crane suffers a hydraulic leak and is out of service.

Crane driver asks FG to assess port side to discharge tubulars.

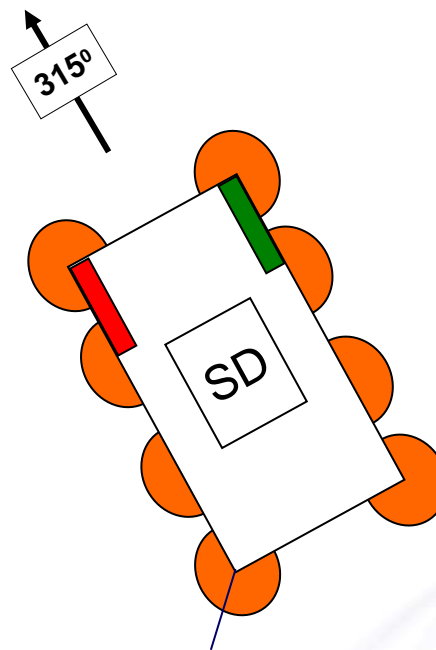
**Time:**  
21:28

**Manoeuvre:**  
Thrusting starboard  
then reversing.

**Event:**  
Master decides to go  
around to the other  
side to take a look.

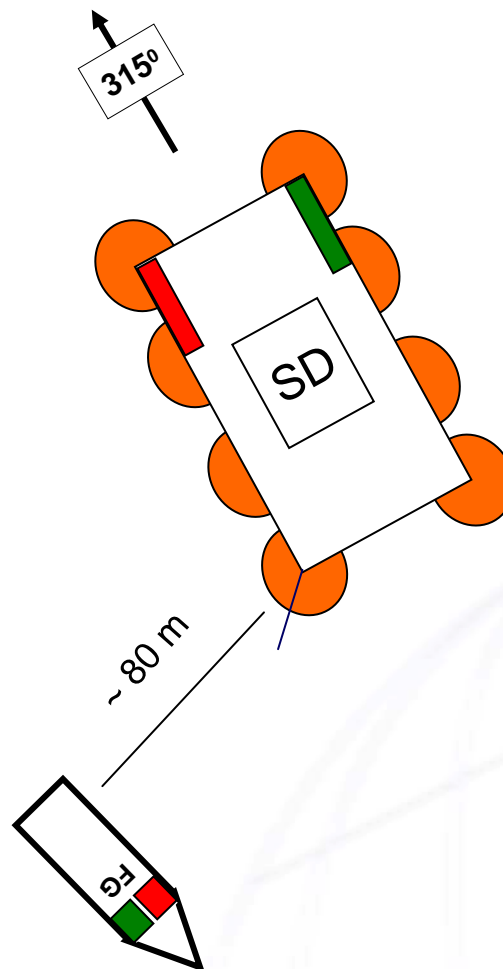
**Time:**  
21:30

**Manoeuvre:**  
Turning

**Event:**  
Setting up vessel to assess.

Distance to rig:  
~ 80 meters.

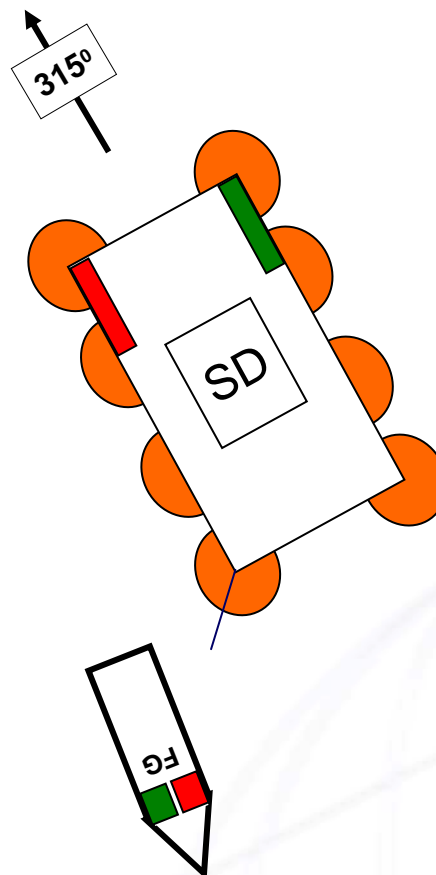
**Time:**  
21:32

**Manoeuvre:**  
100% on thrusters  
and full ahead

**Event:**  
Master intended to  
give the vessel a  
push forward.

Deck lights went out  
due to heavy  
consumption of  
electrical power.

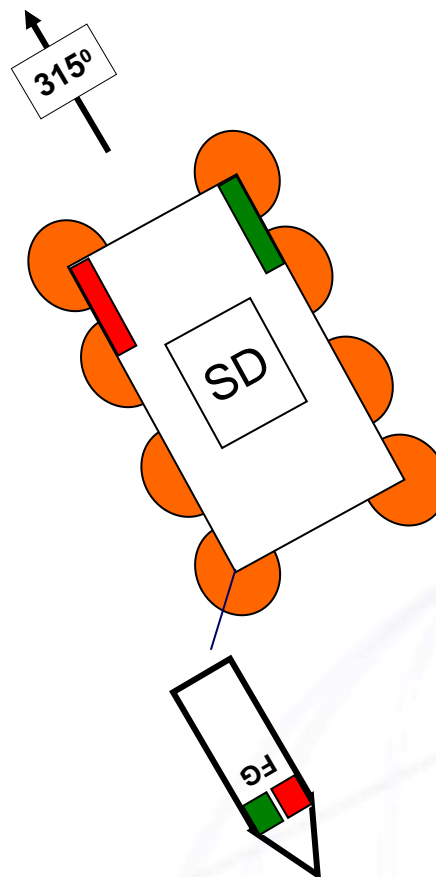
**Time:**  
21:32

**Manoeuvre:**  
Pitch is off main  
Full SB thrust

**Event:**  
Master zeros pitch  
on main propellers.

Engine room asked  
if OK to use main  
engines. Confirmed  
OK. Lights come  
back.

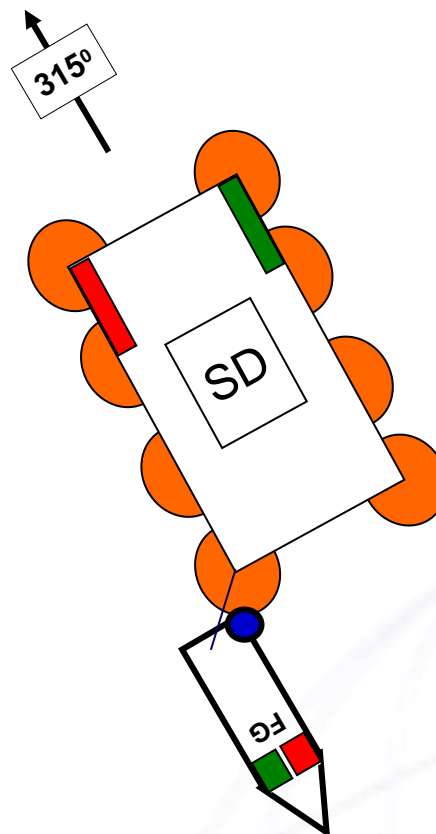
**Time:**  
21:33

**Manoeuvre:**  
Full ahead –  
Full SB thrust

**Event:**  
Hits aft port leg

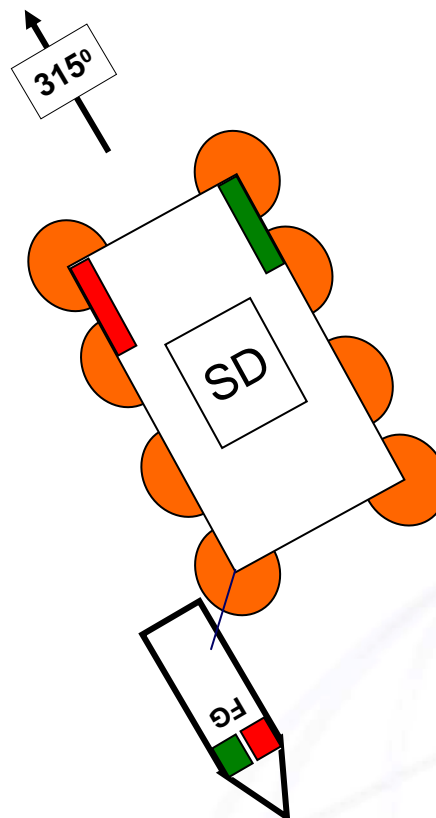
**Time:**  
21:34

**Manoeuvre:**  
Trying to pull away  
From the rig.

Port engine stops  
as port propeller  
tangled into the PCP.

Fire alarm sounds  
when gear box  
breaks down.

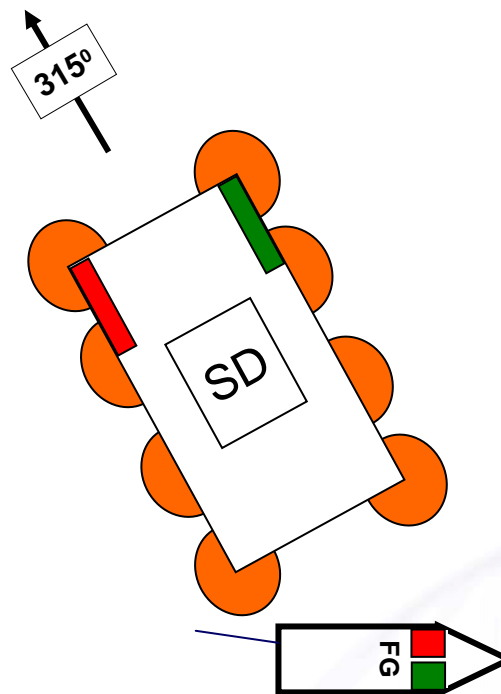
**Time:**  
21:34

**Manoeuvre:**  
Thrusting away from rig.

**Event:**  
PCP (#5) pulled loose from Songa Dee's deck.

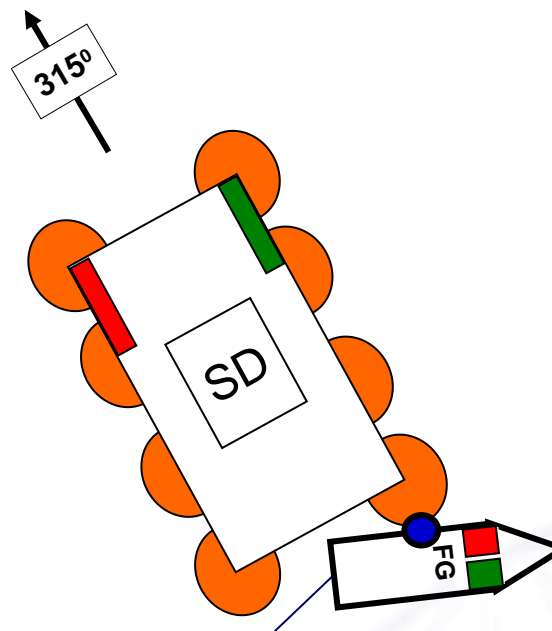
**Time:**  
21:35

**Manoeuvre:**  
Thrusting away from rig.

**Event:**  
Vessel drifts into Songa Dee's aft SB Column.

Not enough thruster power to stay away from column.  
Focus on minimizing damage.

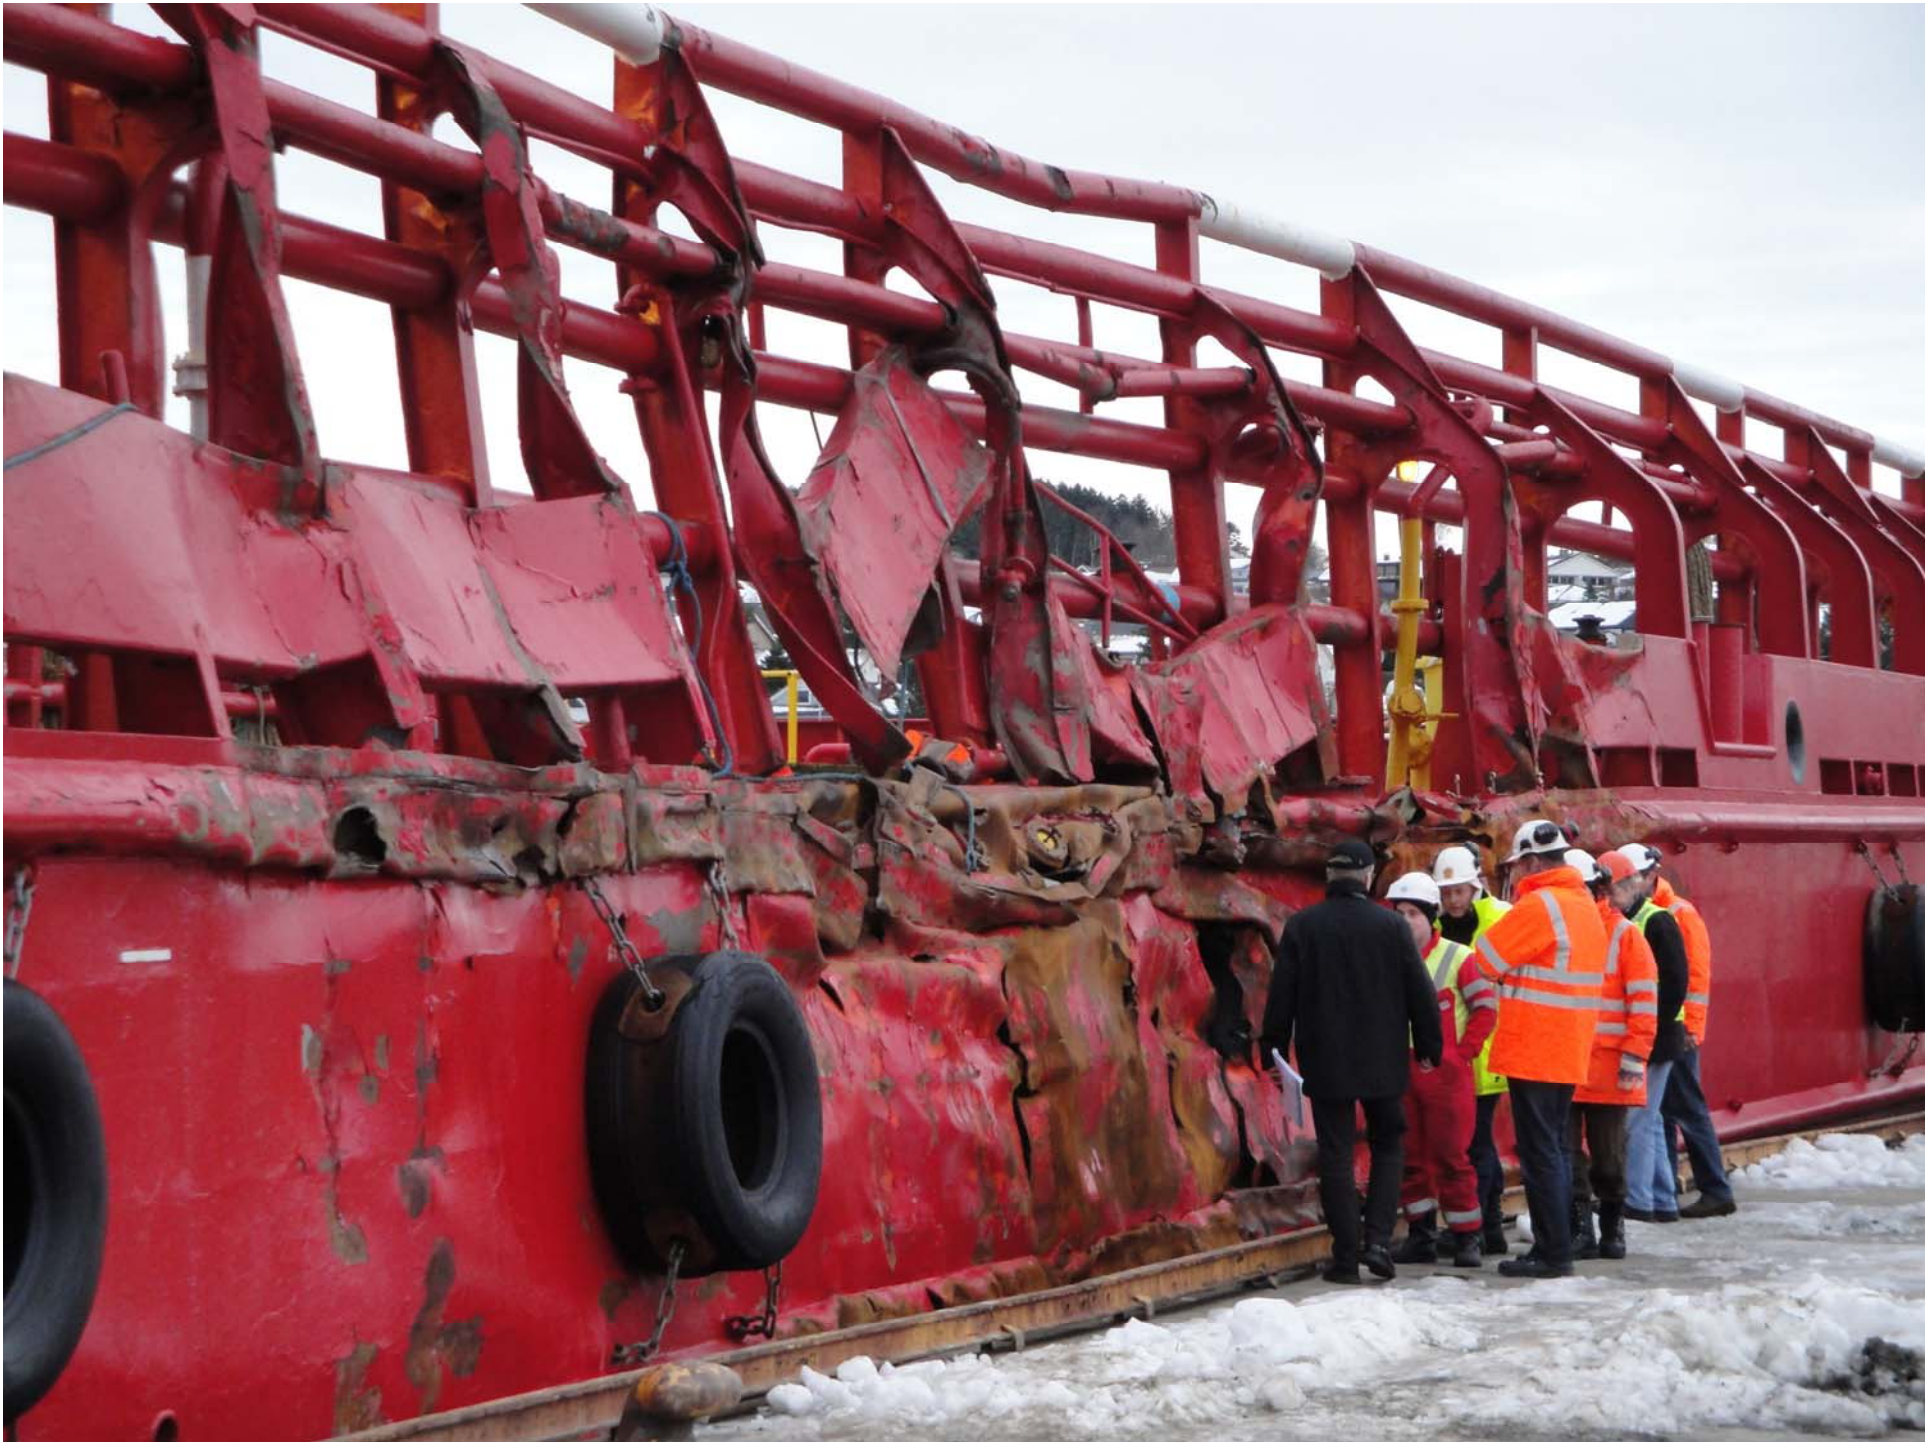
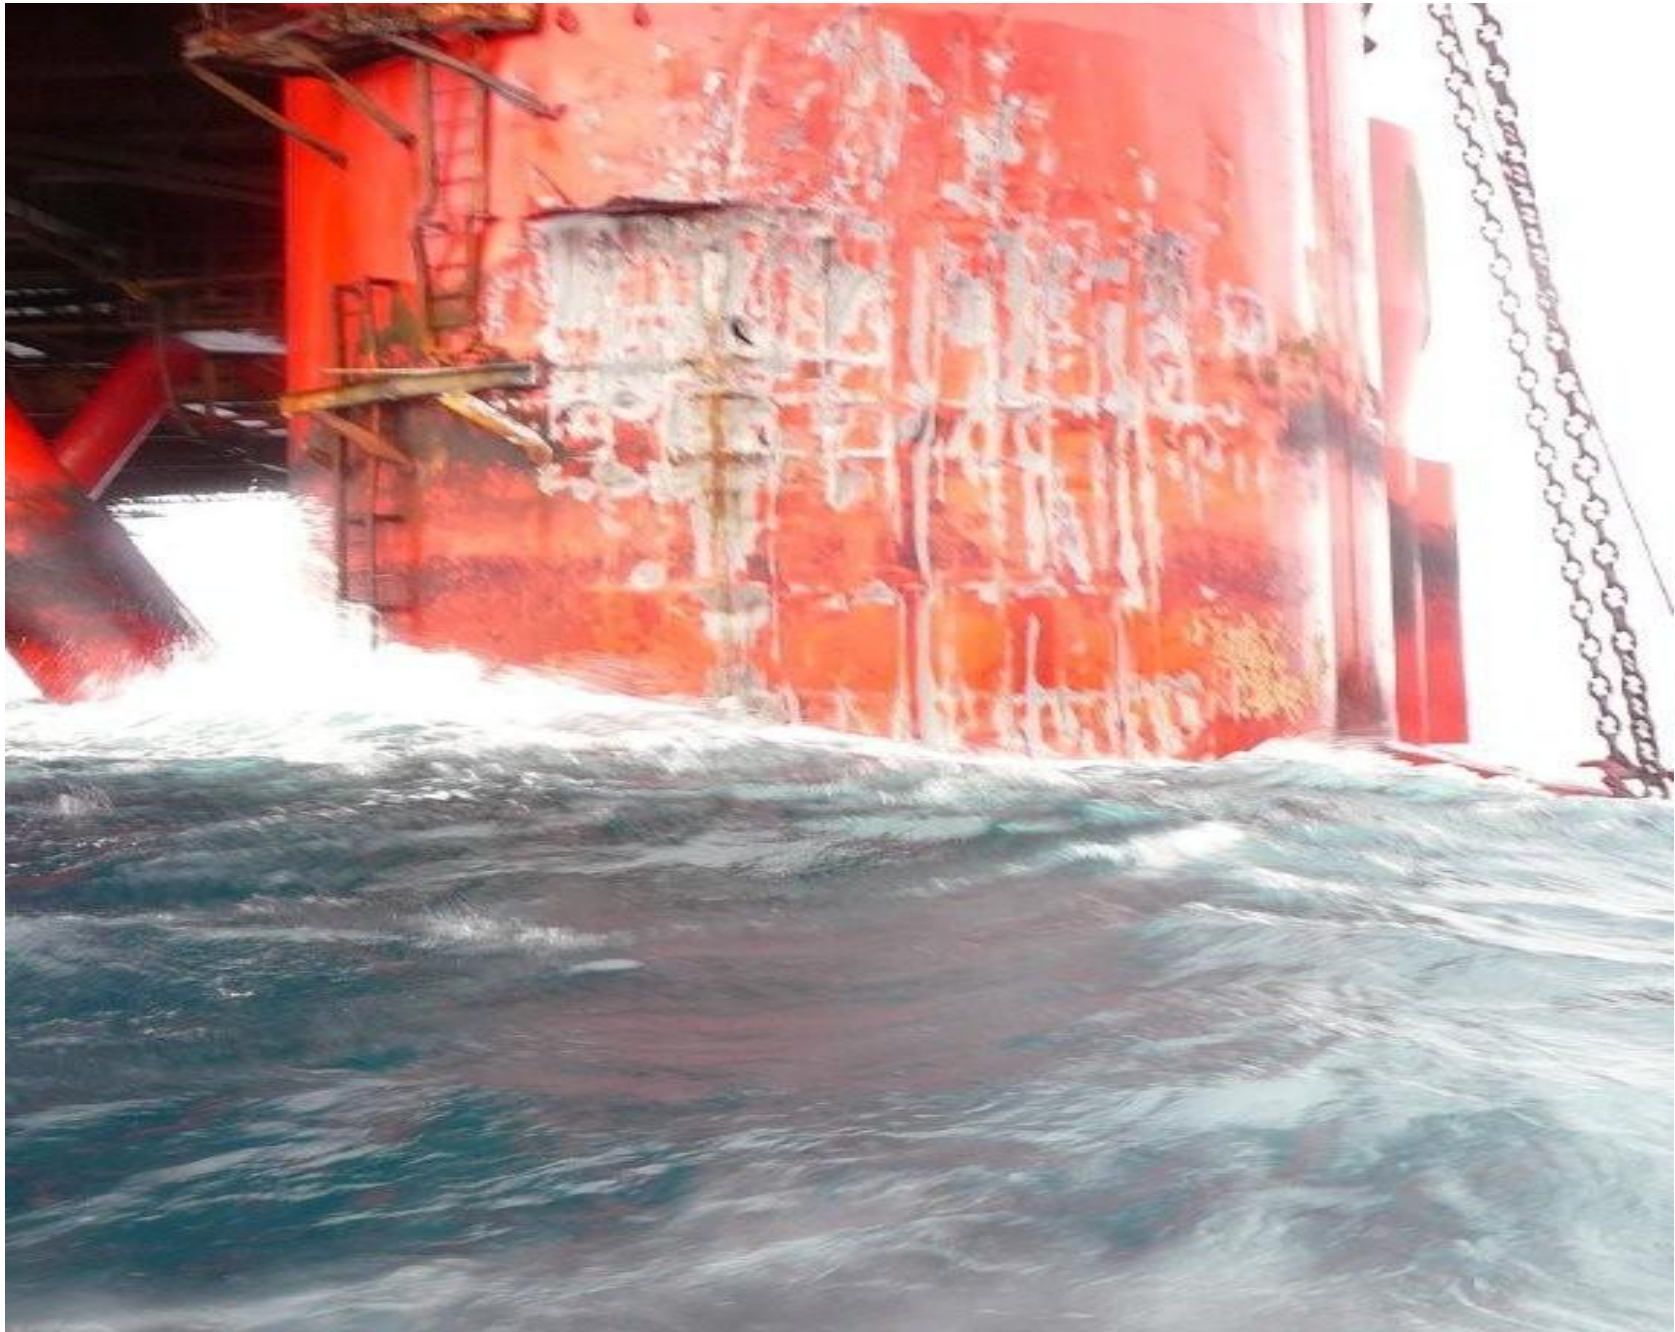
- ◆ Vessel trapped alongside rig for ~2hrs
- ◆ Contacted rig leg ~60 times
- ◆ Captain used remaining propulsion/thrusters to maintain station and prevent vessel from going under rig
- ◆ Drillers coming out of hole at time. Well quickly secured.
- ◆ Partial down man of rig
- ◆ ERRV attempted tow but lines failed
- ◆ Tugs used to pull clear to limit allowed by chaser
- ◆ Rig ROV cut chaser wire with hydraulic cutter flown from beach.
- ◆ Emergency response by all parties was professional and well organised
