# Drift-off incident - Maersk offshore vessel @ Gryphon A

# Incident description

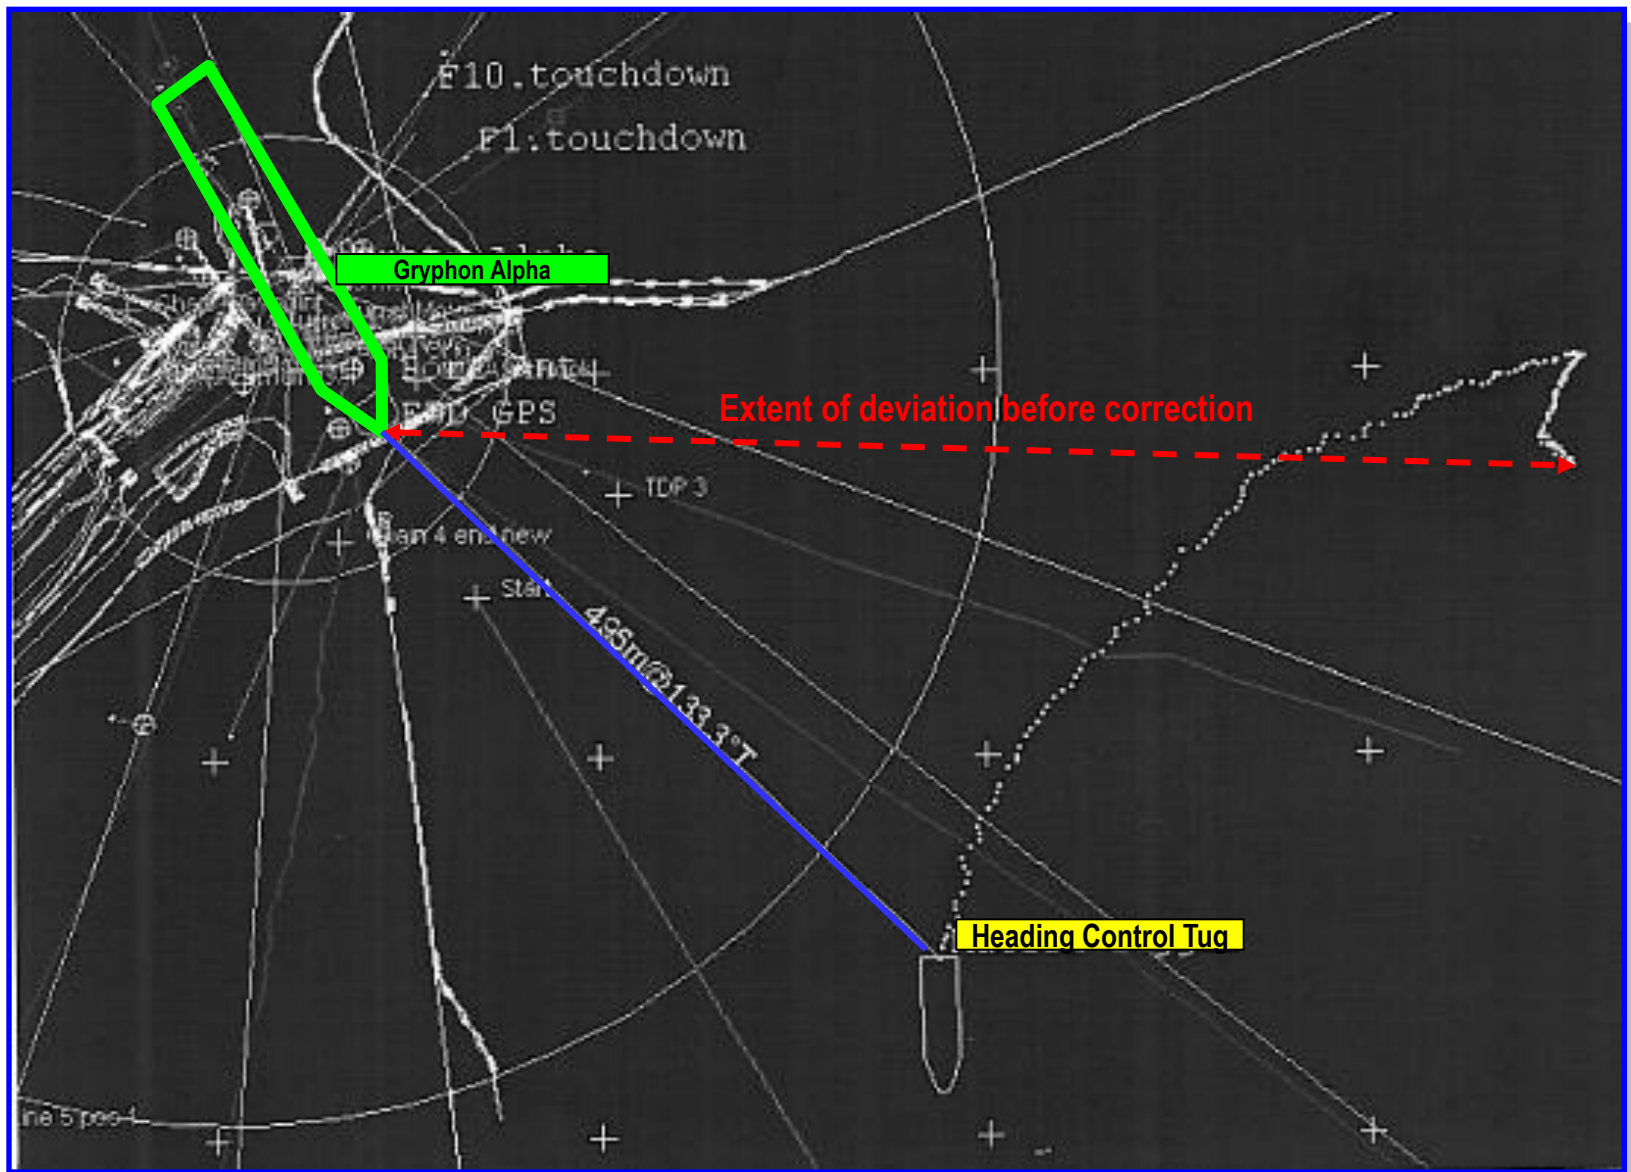
- During the night of 23<sup>rd</sup> February the weather increased to 5.5m significant wave height with maximum waves of around 9 meters from a general South-easterly direction with wind gusting to 65 knots were experienced.
- It was reported by Gryphon that the offshore vessel was seen to deviate from his position upwind of the FPSO and move to a position approximately 500m to the East of the installation before returning to the correct position.
- This occurred between 2030-2040hrs on 23<sup>rd</sup> February.
- It was ascertained from the vessel Master that this excursion was the result of very large seas affecting the vessels heading control whilst in manual operation.
- He stated that 2-3 very large seas struck the vessel in succession which deviated the vessel heading such that the wind 'took hold' of the bow and the vessel moved bodily to the East.

- The Second Officer was on watch as the sole watch-keeping Officer on the bridge at the time. He was maneuvering the vessel in manual mode through the use of individual controls for main engines, rudders and thrusters.
- The tow-wire was at 860 meters length and tension of the tow was at 55 tonnes at the time of the incident. The tow-wire was held in position aft through the towing pins on the centre-line of the offshore vessel.
- The Master was called and quickly attended the Bridge where he took command of the vessel, paid out some tow wire and corrected the vessels heading before gradually bringing the ship back to optimum location.
