Maersk Feeder – Collision with Thistle Platform

What happened and lessons learned

29 November 2009

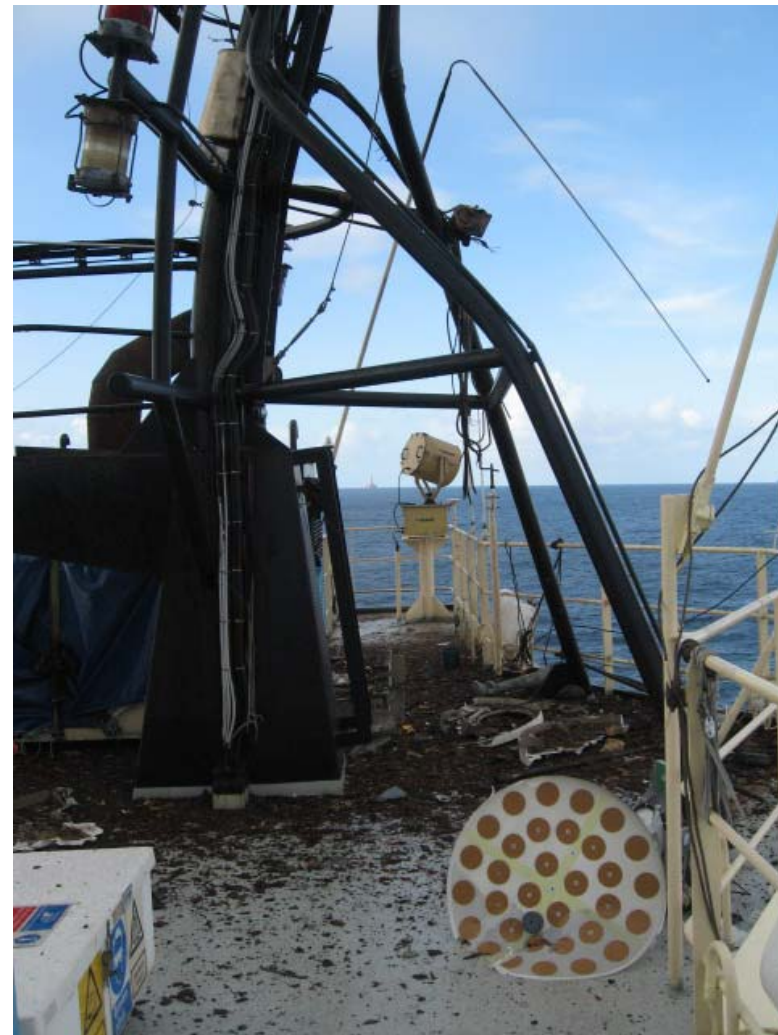
- Slight damage to platform
 - Redundant dive control area
- Significant damage to vessel
 - Main mast
 - Communications aerials
- No personal injuries

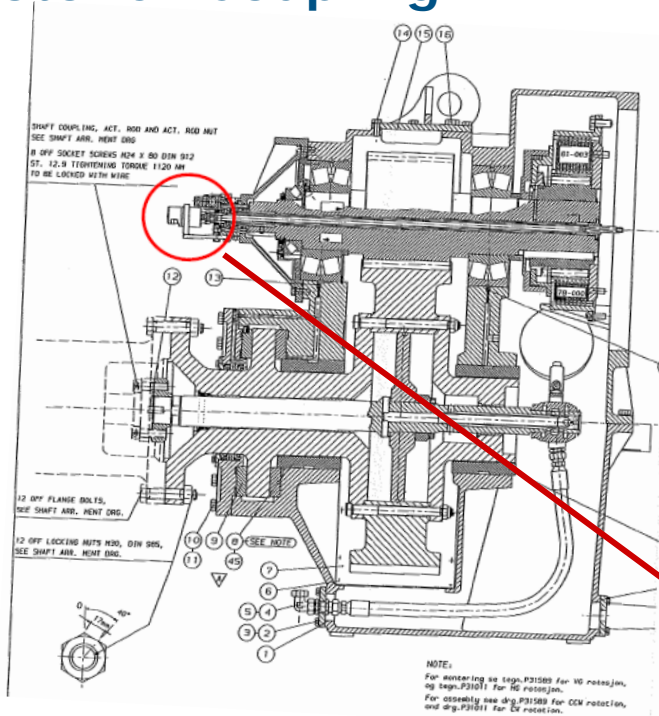
Rotoflex Coupling

- Failure of Rotoflex coupling seal on port gearbox

- No change out period in maintenance system
- Azimuth locking PLC power loss

- Vessel crew commended for professional response
- All Rotoflex unit renewed (all F-types)
- Safety Flash issued to Maersk fleet
- Proving trials to Master and charterer satisfaction
- Maintenance system updated
 - Renewal every 3 years (less than manufacturer recommendations)
- 24V – 220V inverter fitted to power Azimuth locking PLC
- Maersk inform ship builders of incident and modifications

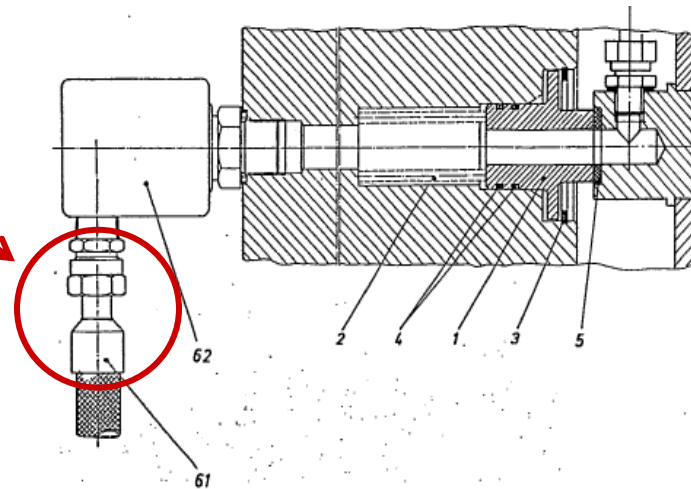
- Fitting to connect air line failed
- Gearbox declutches alternator and prop lost
- Fitting had not been replaced
- Not part of maintenance system
