PLATINUM EXPLORER

FATAL INCIDENT – 31ST JANUARY 2011

HSE Presentation - 022

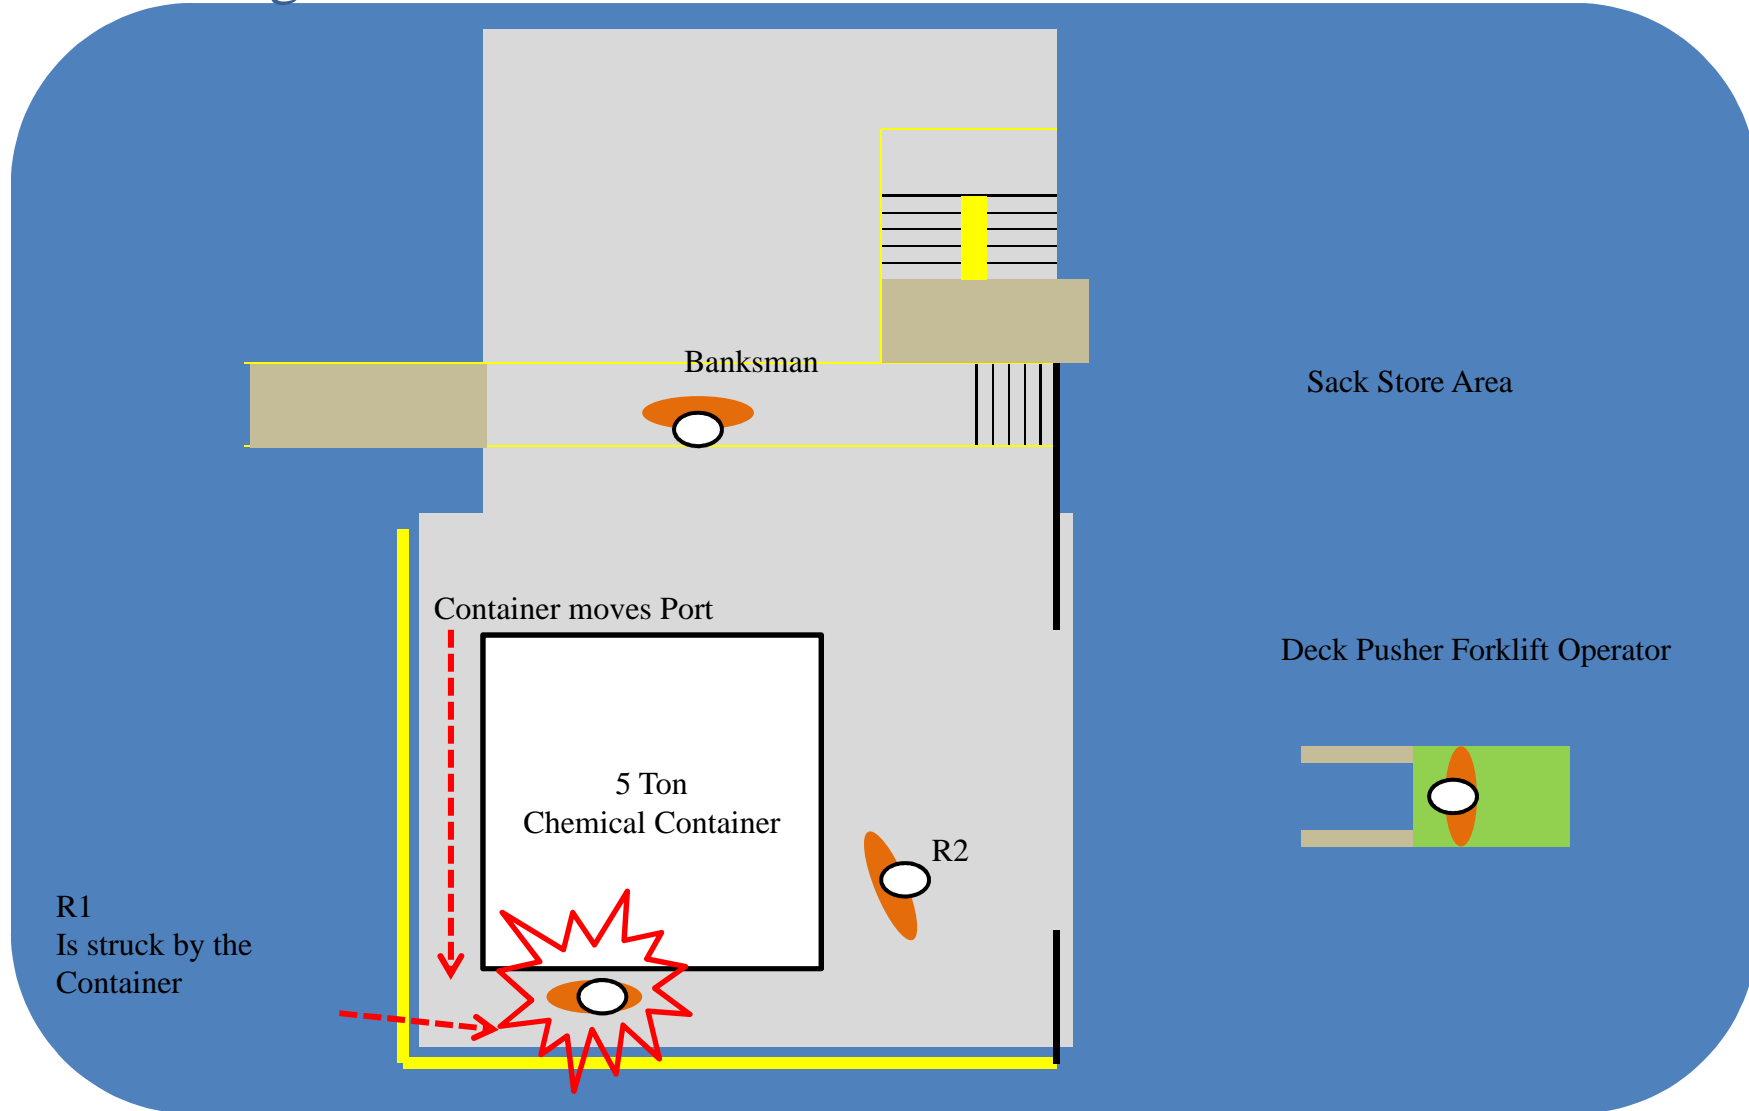
Diagram of Incident Area at the Time of the Incident

R1 remained in position between the container and the landing platform handrail. As the container was raised quickly the bottom edge of the container gave a glancing blow to R1's lower abdomen on its way pass causing a fatal injury

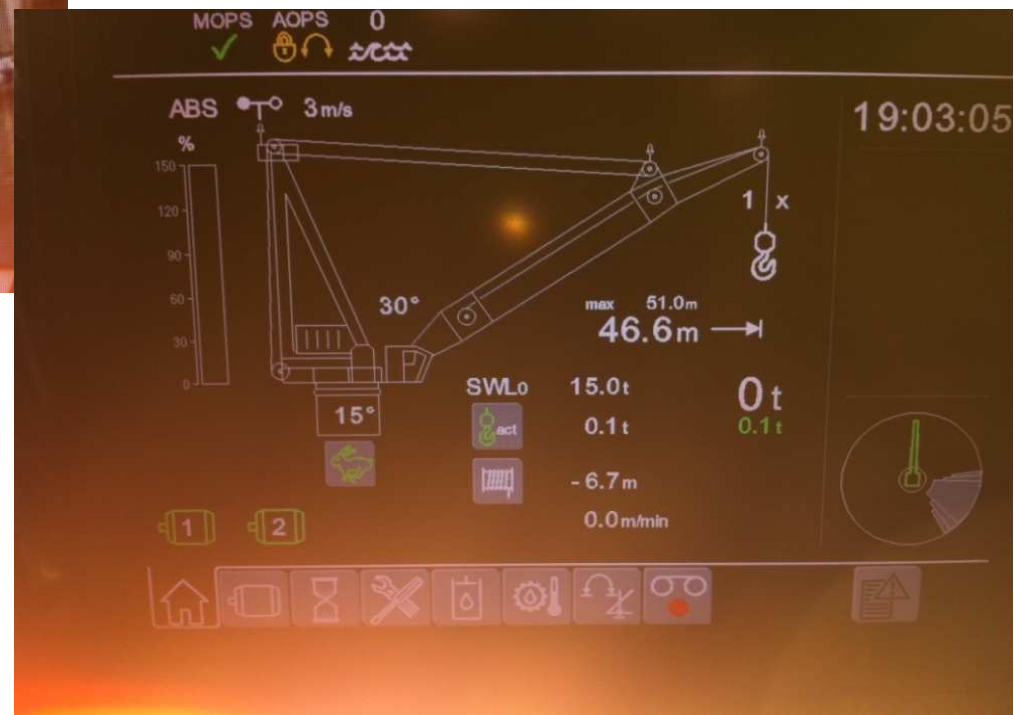
Boom Tip Camera View
at the time of the Incident

The Banksman and R2 advised they observed after the 1 ton sling was removed, the whip line was picked up quickly with the boom still off center, the whip line came tight and the container was lifted off the deck and up quickly swinging in the direction of R1 *The Crane Operator failed to use and understand the technical aids correctly in the crane, as well not looking at the boom tip camera display to identify the position of his crew prior to lifting the load quickly.*
