Marine Safety Forum – Safety Flash 06-15

Issued: 24th April 2006

Subject: Hand Injury to Vessel Deck Crew

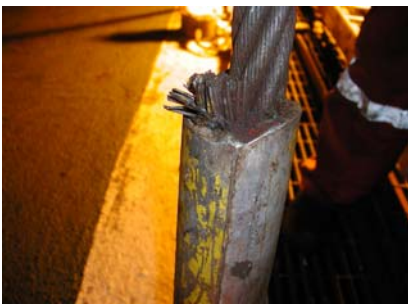
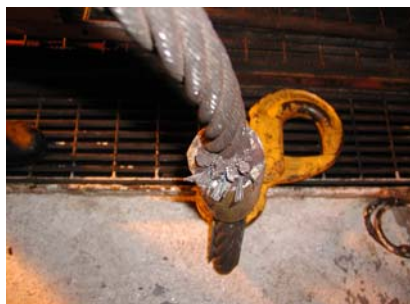
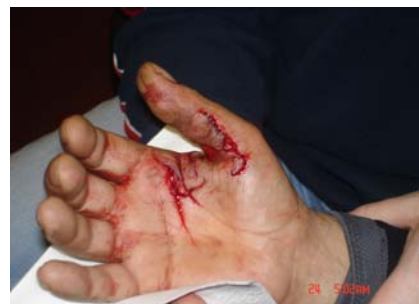
A vessel was discharging heavy lifts at a MODU and the main block with a heavy lift pennant was in use. The weather was marginal and increasing, but it was within the company guidelines. The deck crew had sanctioned continuation of work just five minutes before the accident occurred. The deck crew consisted of two men, one man tending the wire whilst the other effected the hook on. Due to the vessel rolling, the crane had the apparent motion of lowering and heaving. As it lifted off the deck, the wire slipped through the AB's hand and a section of damaged wires at the top of the aluminium ferrule penetrated the crewman's hand resulting in a very deep cut.

2. The crane wire termination was a standard aluminium ferrule which is widely used in the industry. The wire tail has to be present to ensure full wire penetration and although they can be trimmed, it is very difficult and carries a high risk of cutting the standing part of the wire. A recommended solution is to utilize crane pennants for offloading / backloading supply vessels which are fitted with a Flemish or 'super loop' type of termination. The sleeve has a tapered top which encompasses the wire ends. It is suggested that they would only be required on crane pennants and not on normal wire slings.

1. The weather was marginal but was within the guidelines. The vessel was rolling and the crane was not able to compensate as they were using the main block. The hook actually hit the deck at one point and, in hindsight, this should have been the point where the operation was halted.

3. The deck crewman was wearing standard PVC gloves with elastic cuffs which keep the hands dry and warm and allow full mobility, but they have the lowest rating for protection against tearing and puncture. It is recommended that companies ensure that they have the right glove for the right job.
