**marine**  
**safety forum**

Hose Deployment & Recovery

28 May 2009: MSF All Members Meeting @Thistle Hotel

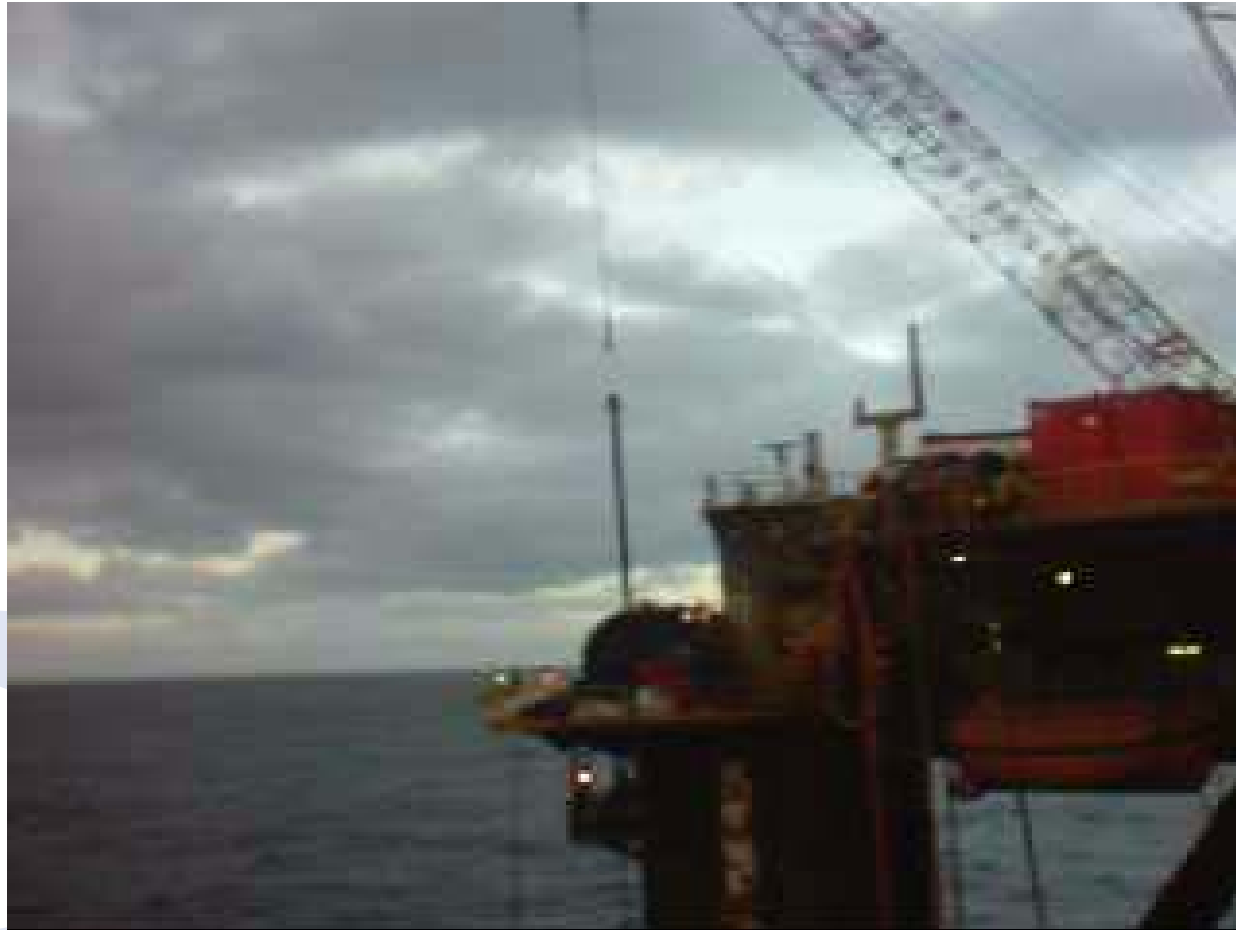
# Video Comparisons Lashing Method

**The hose was lowered to the vessel and the AB's attempted to secure the hose to the ships outer rail using a lashing.**

**The lashing was not fully secured, and when the hose was lowered and the crane hook disconnected, the vessel rose on the swell and the hose was pulled away from the lashing.**

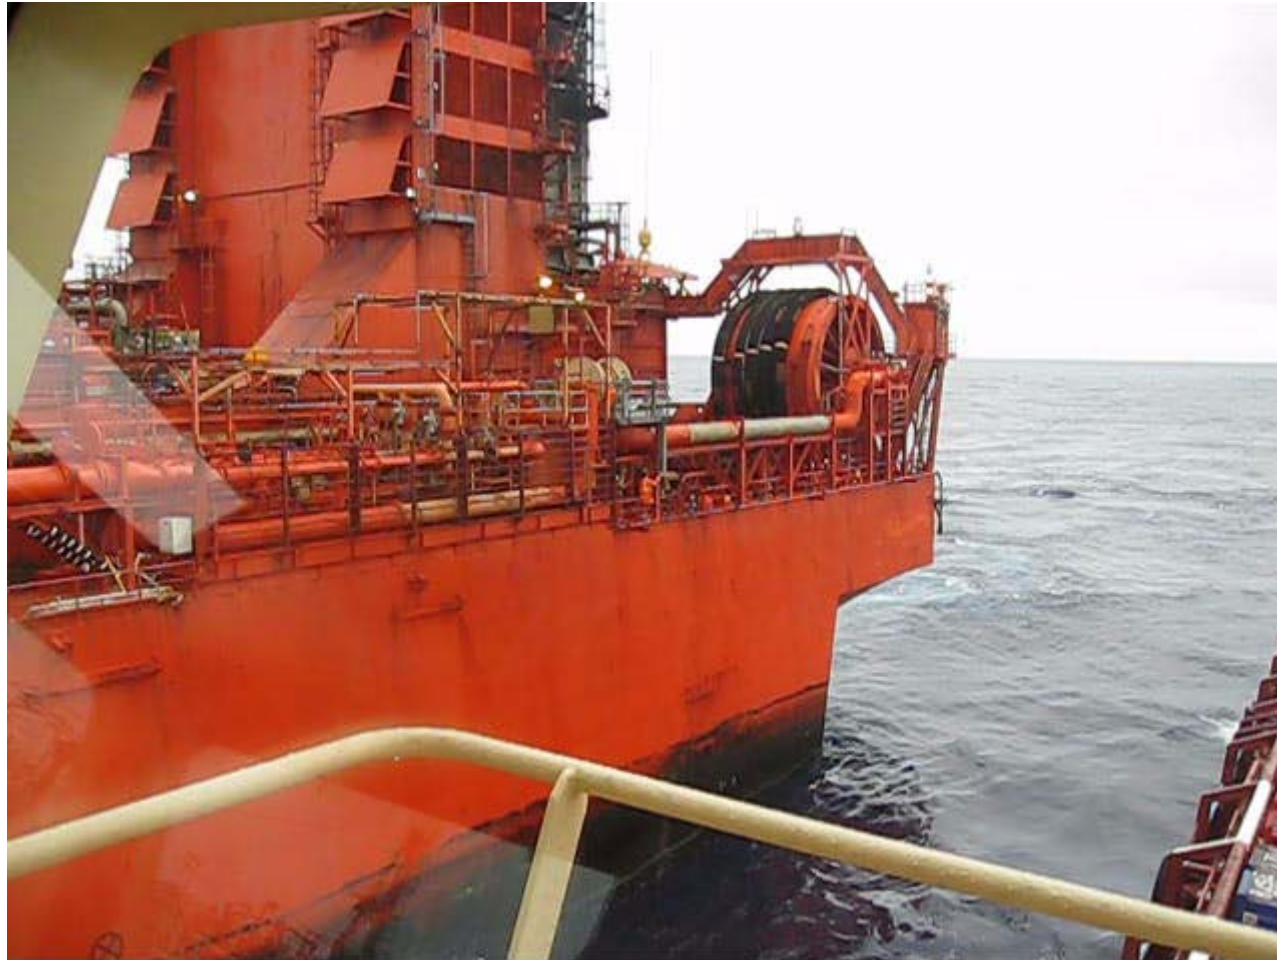
# Hanging Strop Method Deployment

**The MSF recommend the soft sling arrangement should be used whenever possible.**

**This would limit spare hose on board and hold the hose in place until it is disconnected, and placed in a location where it is clear of all snagging hazards and can be safely connected to the crane.**

- **Since full implementation the risk of serious injury of crew while securing and releasing the hose in the deployment and recovery phase has been eliminated, although some manual handling issues remain in the manifold connection / disconnection phase.**
- **Fingers hands and arms are not exposed to the same risk when lashing the hose at deployment, and unlashng at the recovery phase.**
