Platform Collision Incident

Aberdeen Airport Thistle Hotel

Collision with Leman AK/Seafox 4

1st October 2007

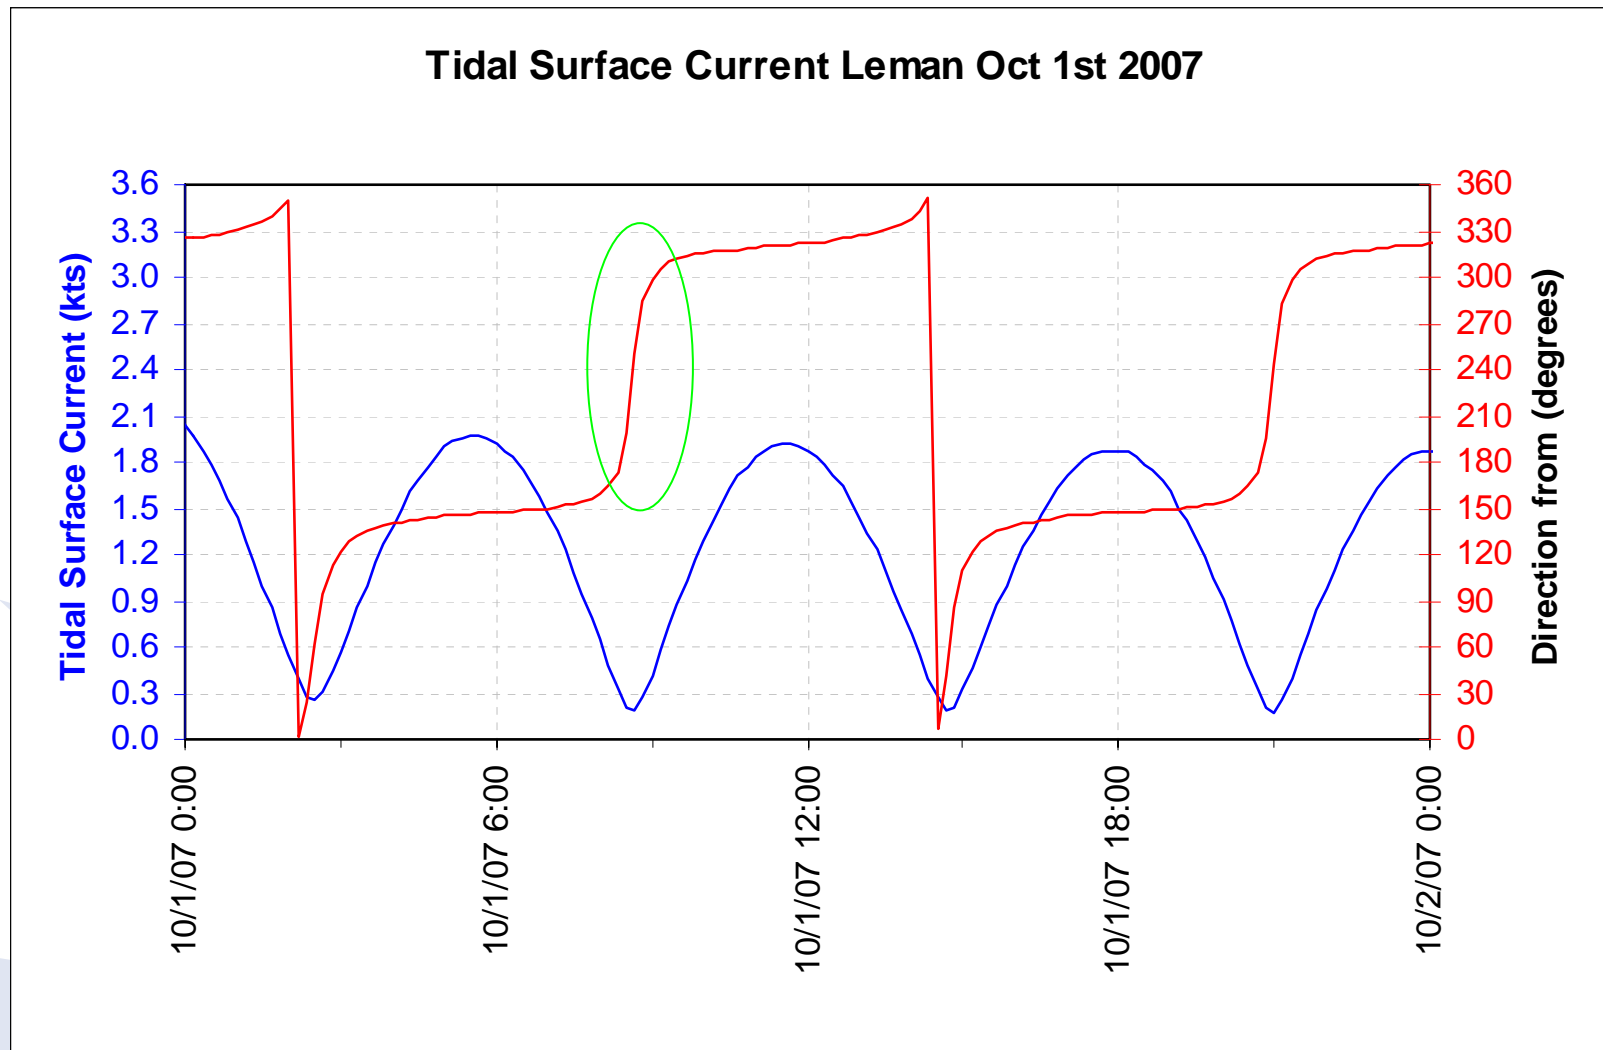
- *Choice of low speed for thruster motors prior to manoeuvres left insufficient reserve power when tidal conditions changed.*
- *Choice of heading required more power to maintain position than stemming tide.*
- *Bridge team had not fully appreciated the effects of the tide*
