Maersk Feeder – Collision with Thistle Platform

What happened and lessons learned

29 November 2009

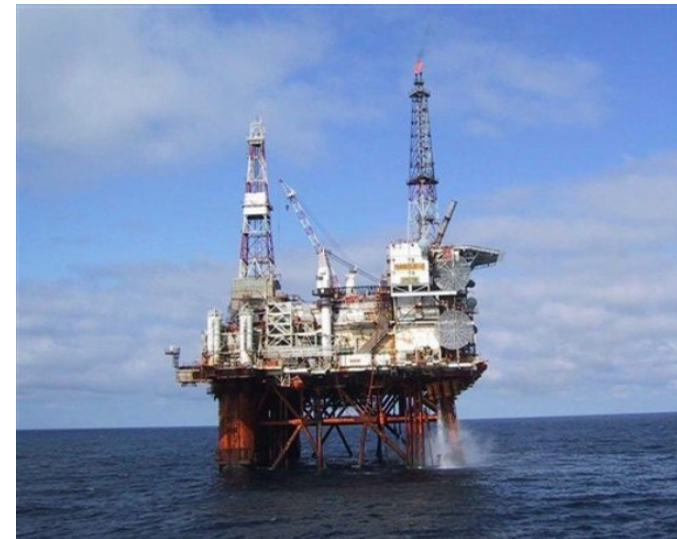
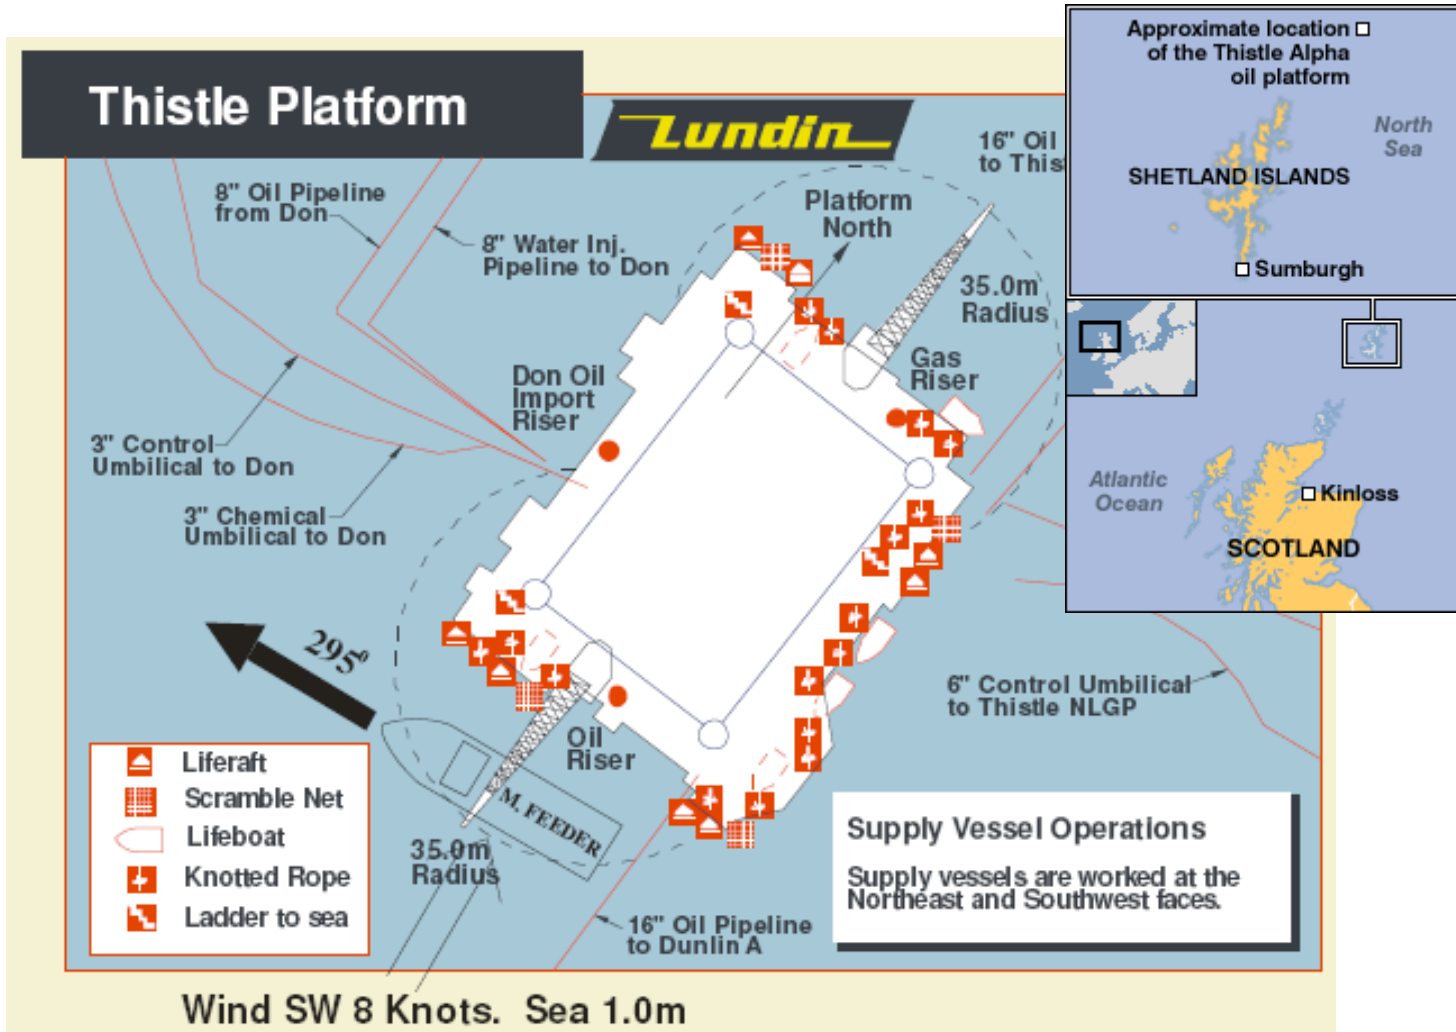
- Low air pressure alarm (port side gearbox)
- Control of vessel retaken by Chief Officer
- Loss of air pressure to port gearbox clutch
 - Loss of port propeller
 - Loss of 2 forward thrusters (azimuth and tunnel)
 - 1 aft thruster
 - Loss of power to emergency switchboard
- Emergency generator auto-starts
 - Power restored to emergency switchboard
 - Auto-start of auxiliary generator restores hotel services
- Deck crew instructed to clear deck
- Stbd propeller moved to ahead to clear platform (bridge thought all thrusters lost)
- Vessel Master arrives on the bridge

- Contact with platform protruding from Thistle A
- Manoeuvred clear

- Slight damage to platform
 - Redundant dive control area
- Significant damage to vessel
 - Main mast
 - Communications aerials
- No personal injuries
